# Evaluation of a Pretrained Deep Learning Model for Indoor Crack Detection Using DSLR and Mobile Phone Cameras

## Abstract

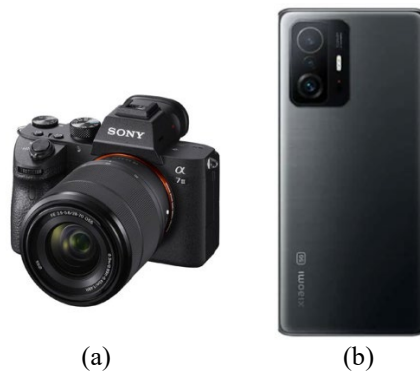
**Figure 2.** Cameras used for image acquisition, (a) Sony Alpha 7 III, and (b) Xiaomi 11T Pro mobile phone.

Two types of cameras were used for image acquisition, as shown in Figure 2. The first camera was a Sony Alpha 7 III equipped with a 29 mm focal length lens and a 24-megapixel full-frame sensor. The second camera was a Xiaomi 11T Pro with a 6 mm focal length lens and a 108-megapixel sensor. Images were captured at an approximate distance of 3 metres from the tunnel walls. This configuration was estimated to produce a ground sampling distance (GSD) ranging between 0.3 mm and 1 mm, which is suitable for detecting cracks within that resolution range.

A total of 246 images were acquired using the DSLR camera, achieving an average ground sampling distance (GSD) of approximately 0.7 mm/pixel. Meanwhile, the mobile phone camera captured 125 images with a finer GSD of approximately 0.4 mm/pixel. This variation in GSD reflects the differences in focal length and image processing pipeline, particularly pixel binning applied in the mobile phone.

The tunnel had an existing lighting system that provided sufficient illumination for image capture. Additional lighting was not required, as the Sony camera operated effectively in low-light conditions due to its larger sensor and high sensitivity. Meanwhile, the Xiaomi 11T Pro employed pixel binning technology to enhance image

brightness in low-light environments. Although this allowed the mobile camera to function without external lighting, it remained susceptible to image noise, which could affect crack detection accuracy.

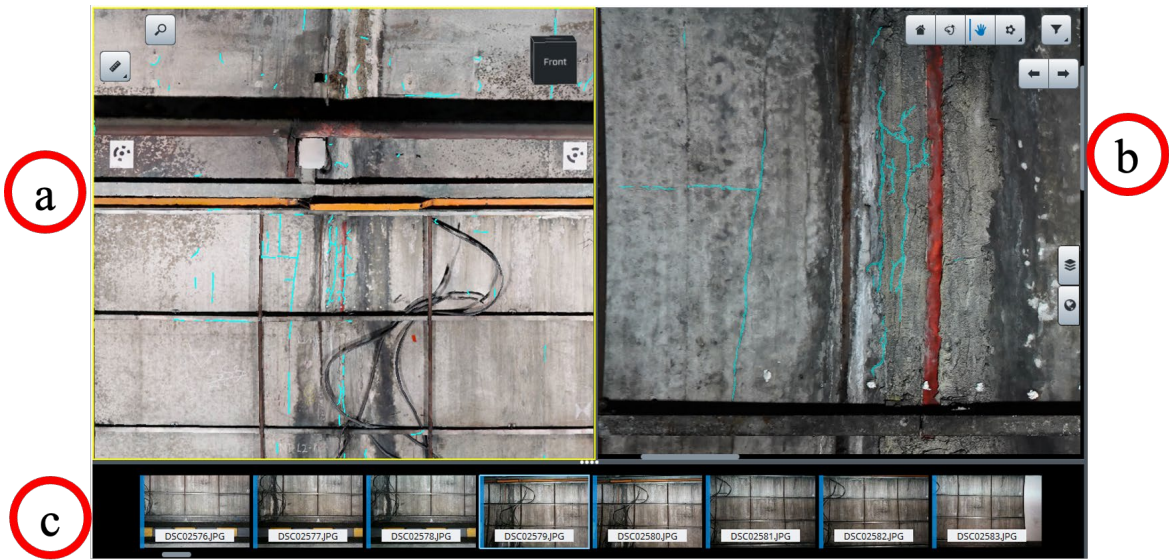
**Figure 3.** Crack detection visualisation in the iTwin interface. (a) Reconstructed 3D model of the tunnel wall showing segmented cracks overlaid in cyan, (b) Corresponding 2D oriented photograph with segmentation overlay, and (c) Image thumbnails used for model reconstruction.

The crack detection model works by analysing each photograph to identify visible surface cracks and generating vector representations in the form of polylines. These vectors were then projected onto the corresponding locations on the 3D model using orientation information derived from the previously performed image alignment process. This enabled spatial visualisation of cracks over a 3D model, and allowed dimensional analysis, including the crack length, width, and spatial position on the tunnel wall. Figure 3 illustrates the segmented crack lines overlaid in cyan on both the reconstructed 3D model and the 2D oriented image.
